Glen Iris Estate

City of Cockburn Community Update

Arborist Review

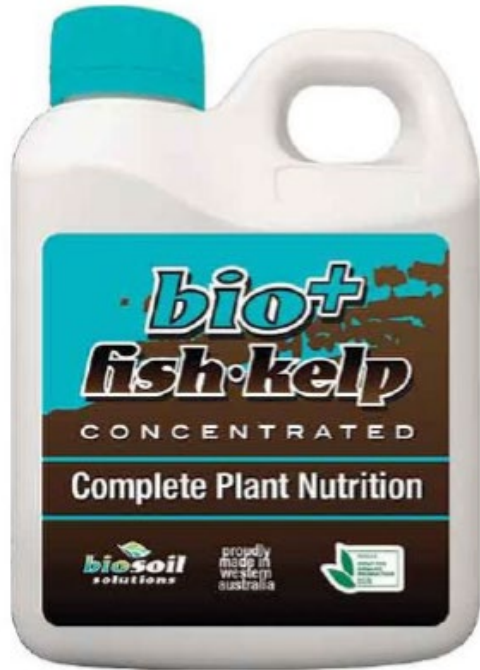
Organic fertilisers used pre and post construction to encourage tree growth and mitigate induced stresses.

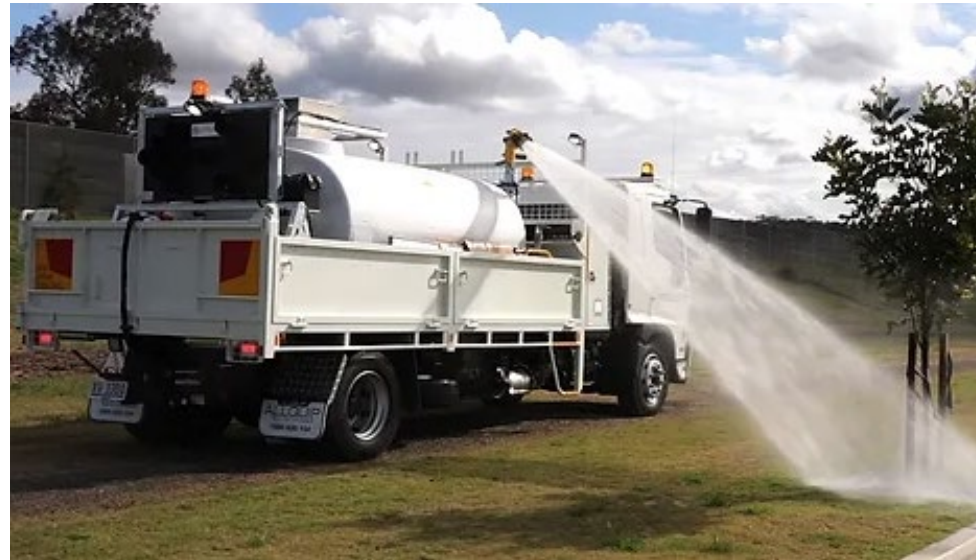
Supplementary irrigation to the trees via. the turret on the water cart to maintain soil moisture (example photo)

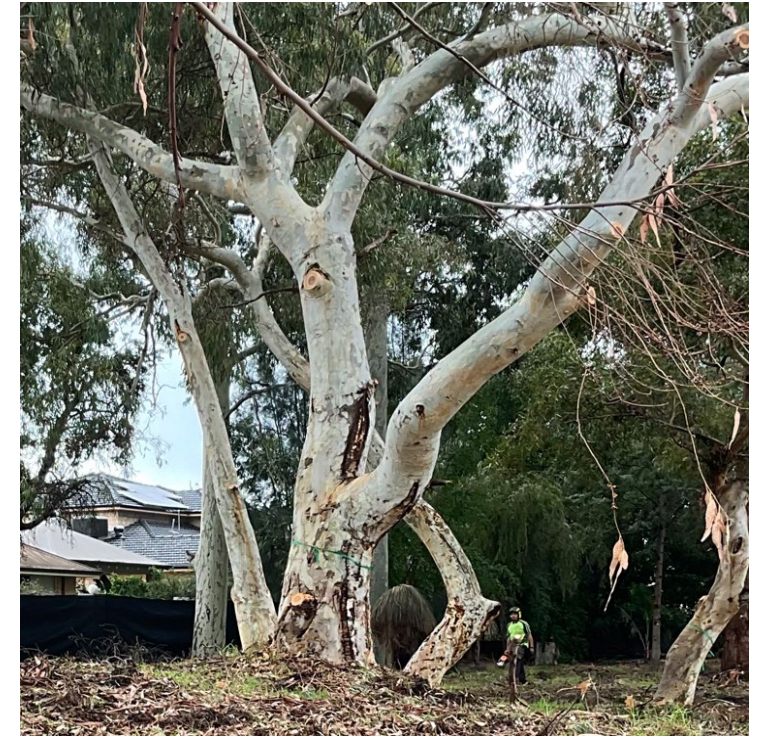
Canopy reduction to reduce the weight of the canopy, balance the tree and reduce transpiration requirements

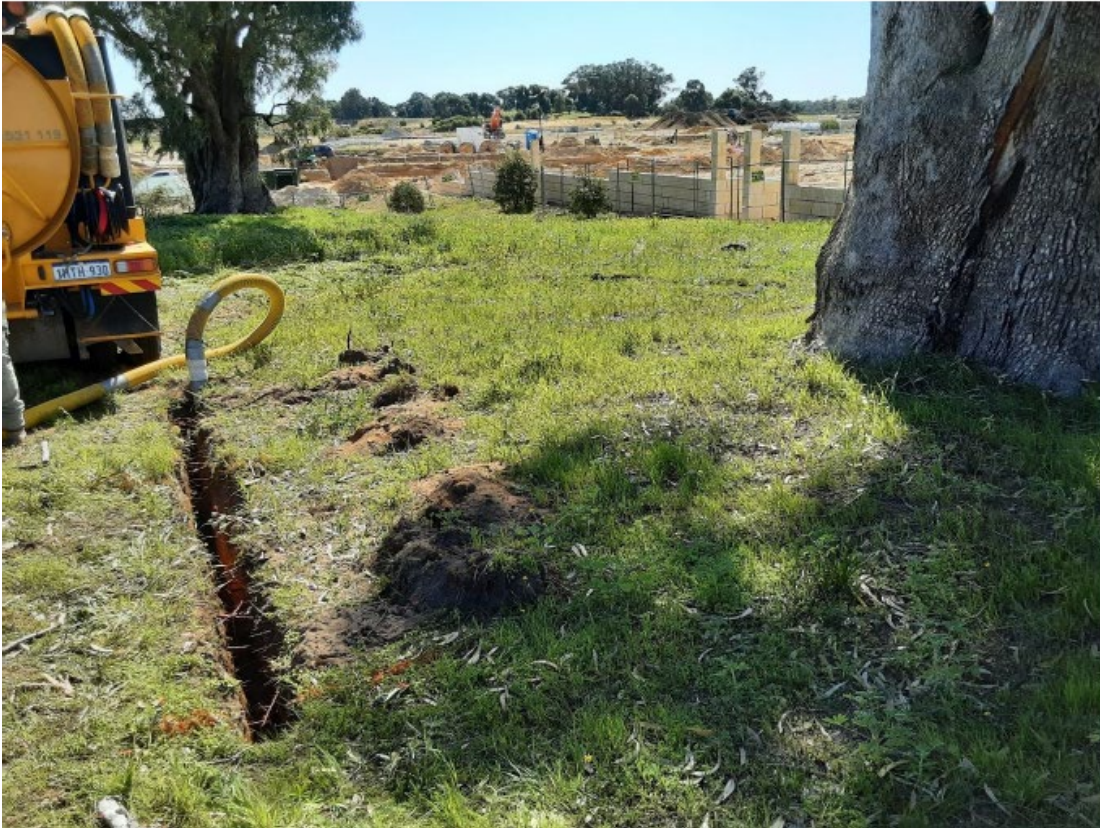
An example of root mapping within the TPZ of a large Tuart, uncovering only 1 root @40mm diameter, allowing construction to proceed without detriment to the tree.

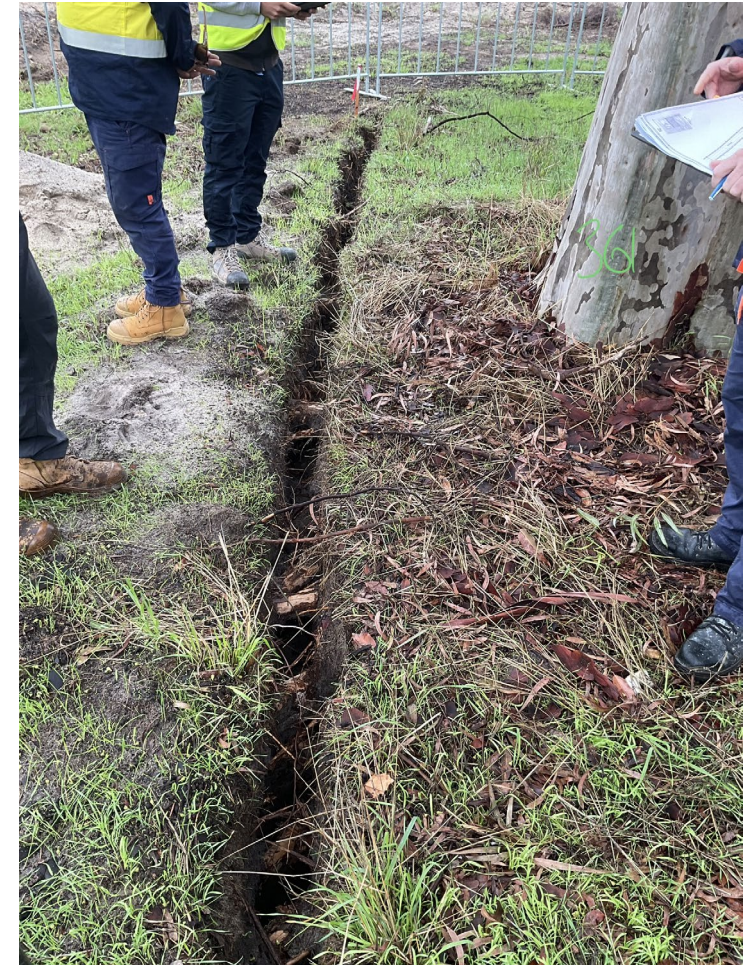
root mapping to determine the level of root removal required and to assist with the viability assessment of the tree.

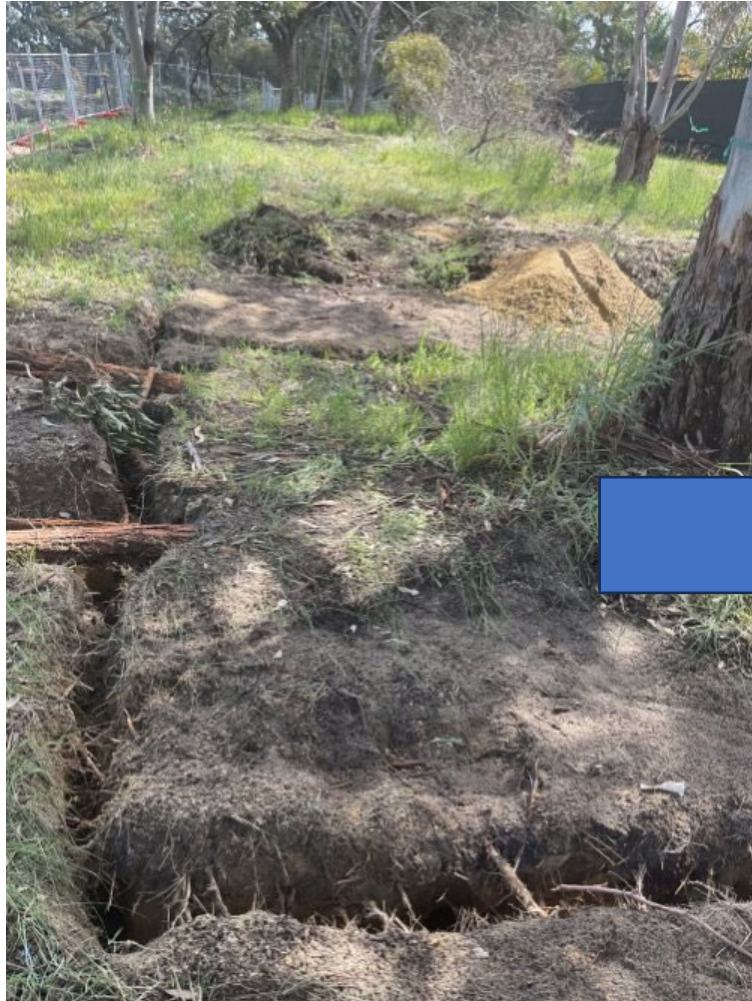
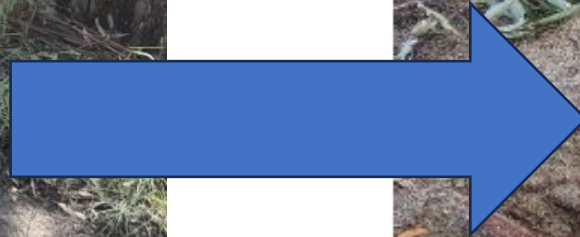
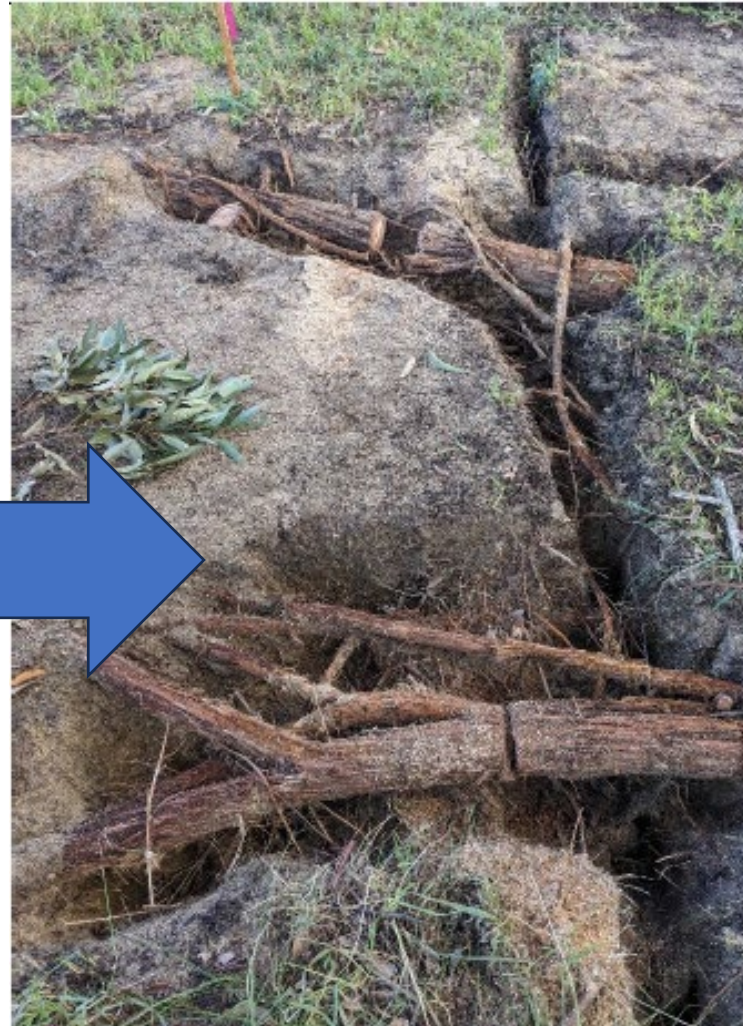
Root mapping to chase and expose roots and clean cutting roots at the desired location to facilitate construction.

With this method, roots can be fully chased and exposed, providing an opportunity to 'clean cut' roots at the precise location and reducing the root damage to the absolute minimum.

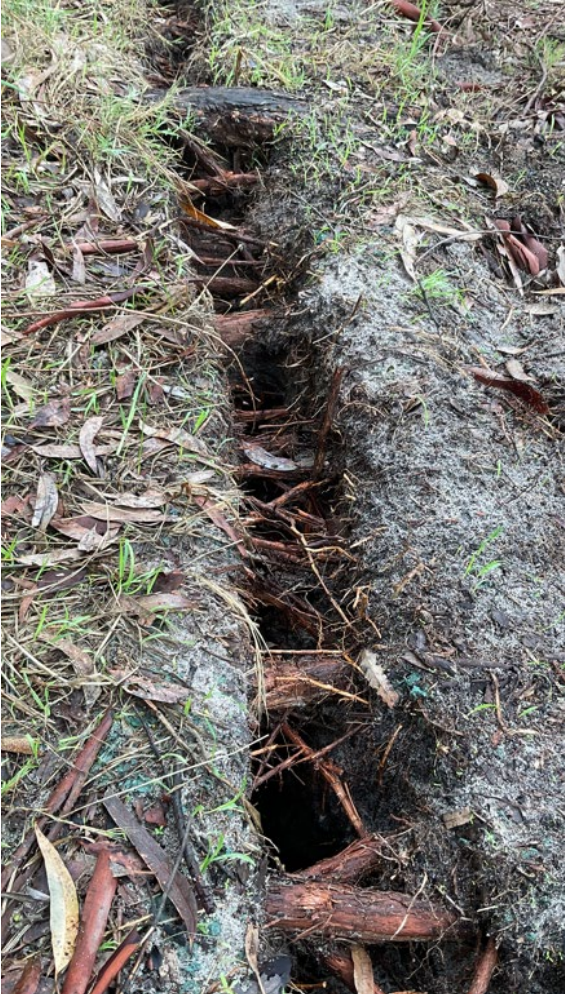
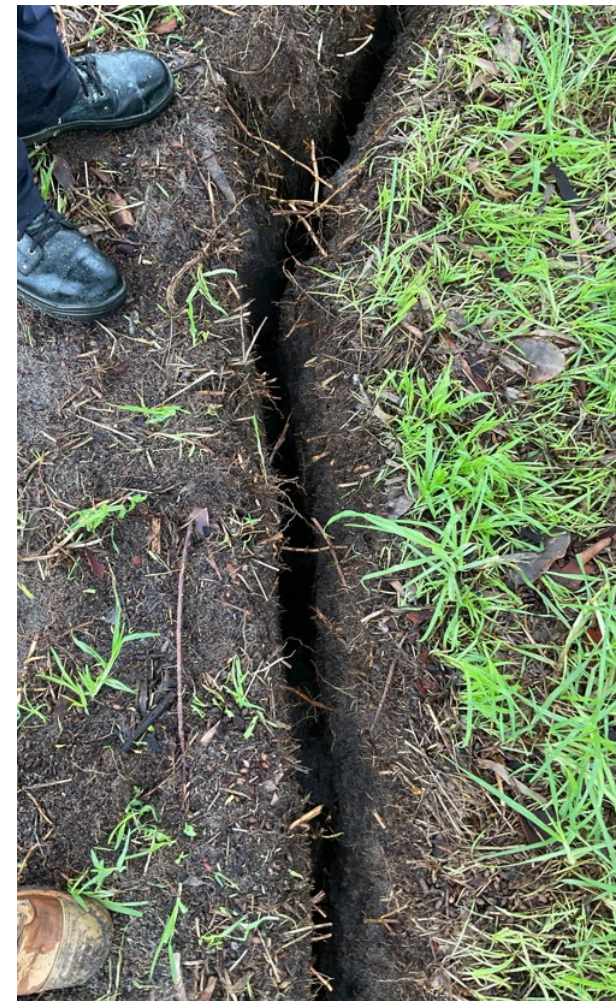
Both images are taken about 2-3 m from the base of trees. The tree on the left shows large roots heading towards the former fairway. The right image shows a trench on the former "rough" side of the tree – with almost no roots present (although plenty of lost Titleist and Callaway balls were found).

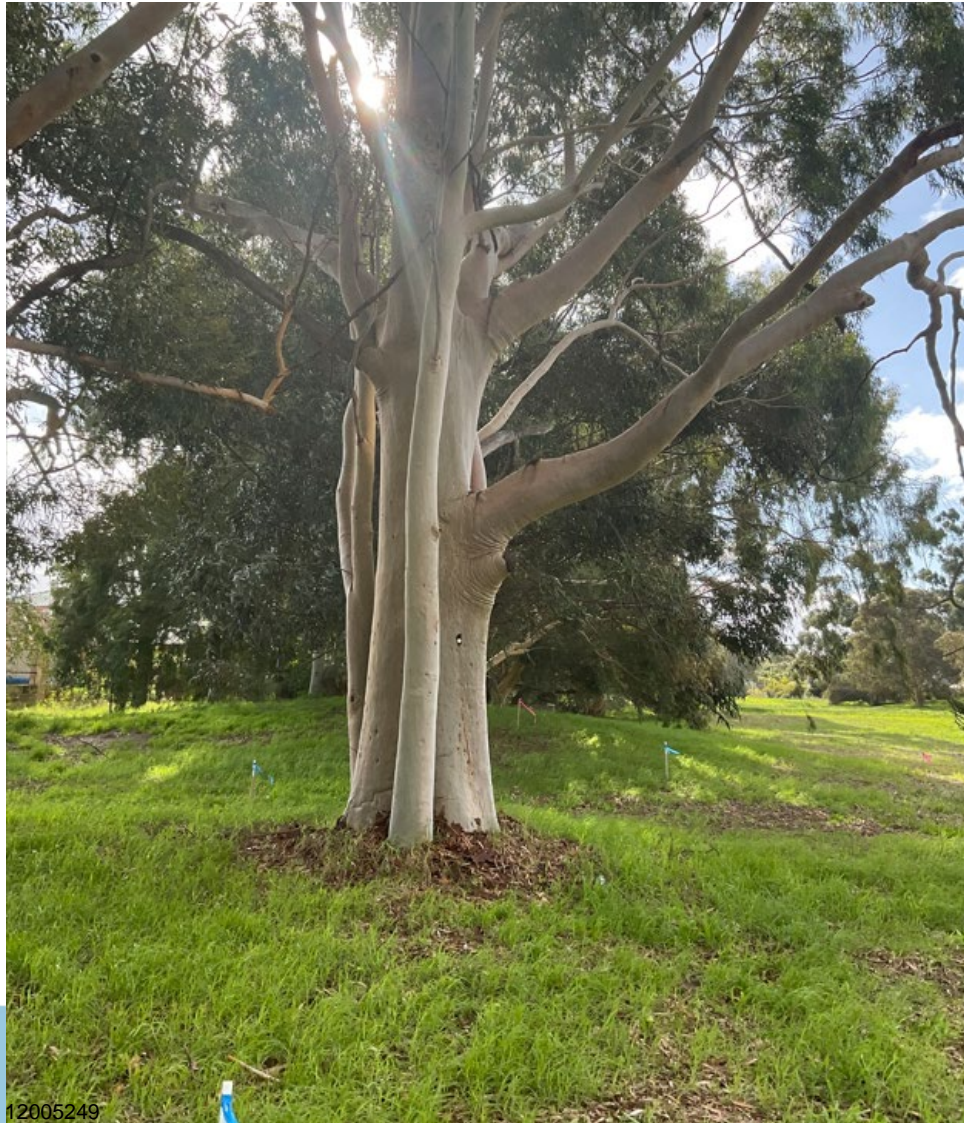
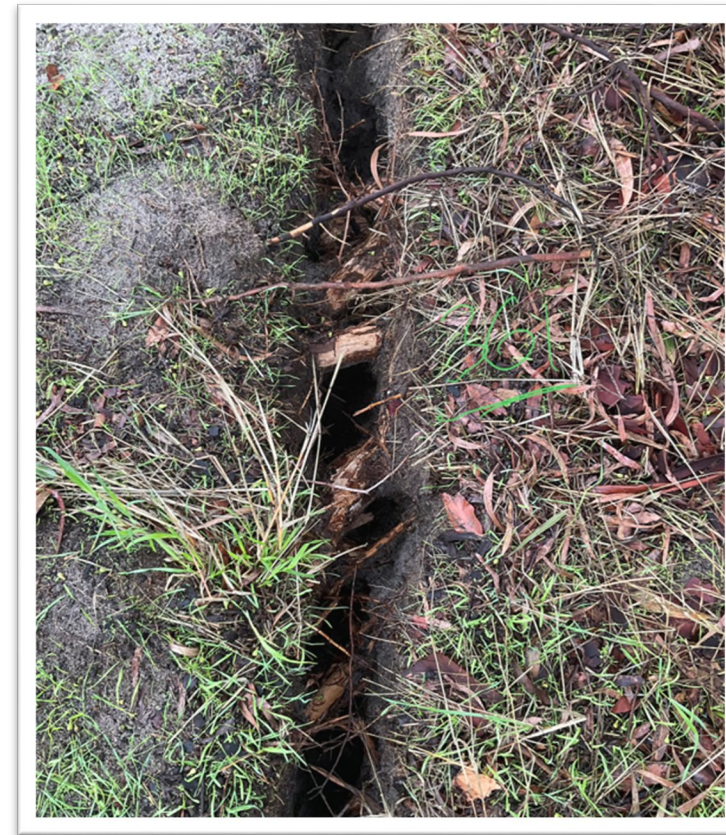
Road 51 and Tree 270 example

Tree 270 with the original road layout staked in blue and a picture of its root mapping

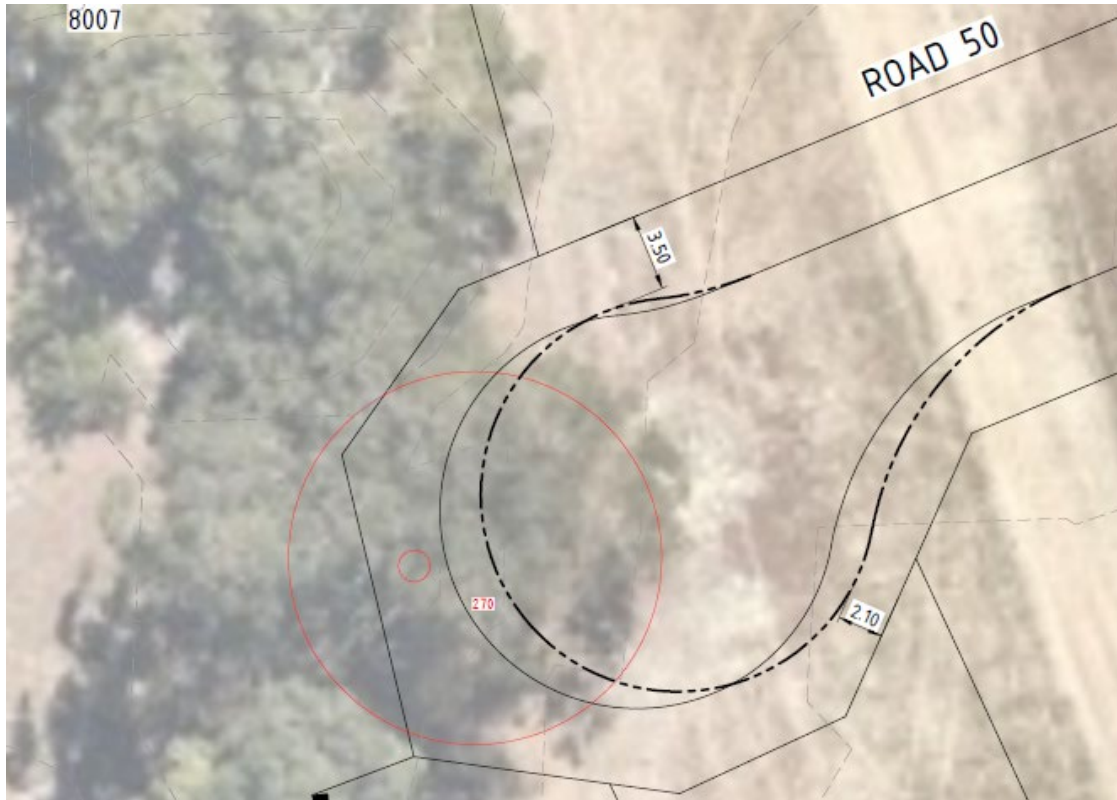
New cul-de-sac alignment in black dotted line
