## Site Assessment

Item	Site 1.5 – Current WHBS location plus Site 2	Site 3 – Carrington Street & Rockingham Road Precinct

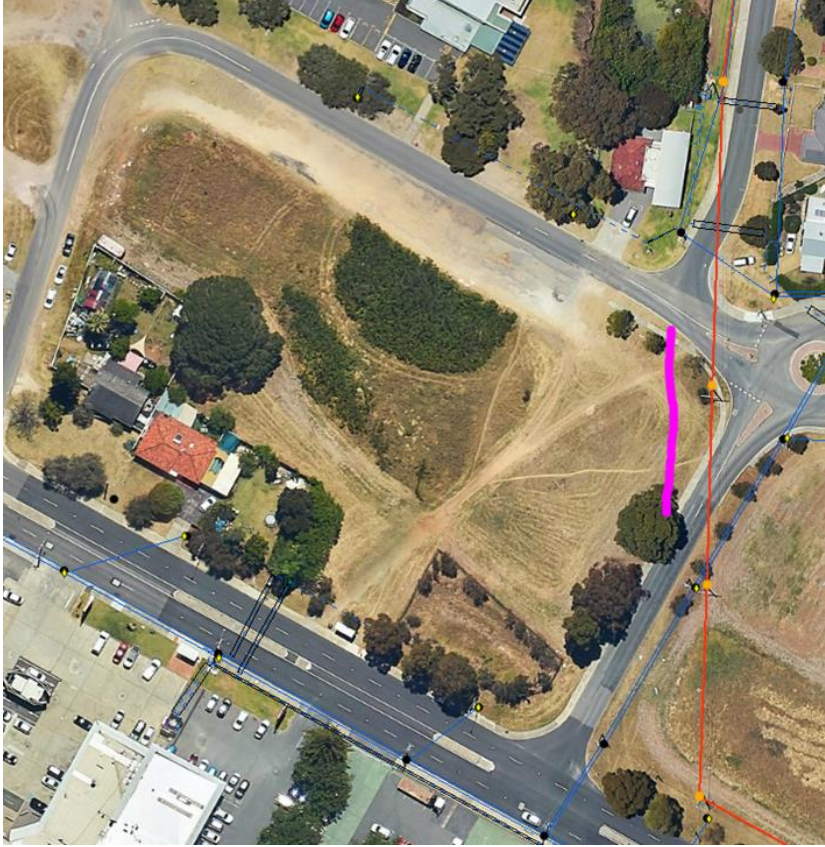
Underground Utilities	<p>Connections in place to existing WHBS and residential facilities.</p> <ul style="list-style-type: none"> <li>- Water Corporation have infrastructure located along the eastern boundary of Dixon reserve.</li> <li>- Western power had infrastructure along the eastern boundary of Dixon Reserve, however outside the site boundaries.</li> <li>- Substation located on the south-east corner of site.</li> <li>- A service line to the basketball Stadium enters the side to the east of the car park. Telstra line entering the site for the basketball stadium which also splits off to three deadlines.</li> </ul>	Connections in place to existing commercial properties.
Hydraulic Services	<p>There are water and sewage networks in the vicinity. Existing connections could be utilised where suitable to Water Corporation's approval, new water and sewer services can be provided off the existing networks to suit the redevelopment of the site.</p> <p>Sewage pumping may be required where gravity sewer cannot be achieved.</p>	Based on the information from Water Corporation, there are water and sewerage networks in the vicinity as shown in the figure below. The existing sewerage only existing in Rockingham Road, with supply connections to Property 110. Existing connections could be utilised where suitable or subject to Water Corporation's approval, new water and sewer services can be provided off the existing networks to suit the requirements of the proposed site.

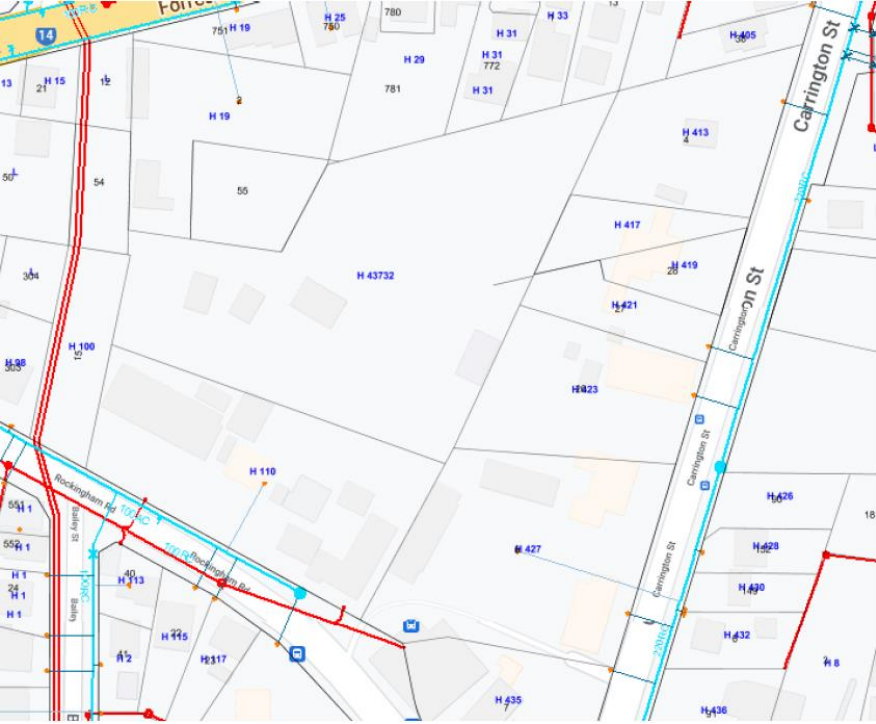
<p data-bbox="315 930 734 954"><i>Existing water and sewer Infrastructure</i></p> <ul data-bbox="360 962 1178 1074" style="list-style-type: none"> <li>- Sewer along the front of existing facility – not actually sure it connects to anything</li> <li>- There appears to be a City drainage basin in SE corner (could definitely integrate in)</li> </ul>	<p data-bbox="1223 148 2096 204">Depending on the internal layouts of the proposed development, sewage pumping may be required where gravity sewer cannot be achieved.</p>

<p data-bbox="1223 943 2051 1023">The sewer connection is only for Memorial Hall. Would need a pump system if Clubroom was at northern end. Big separation to groundwater</p>

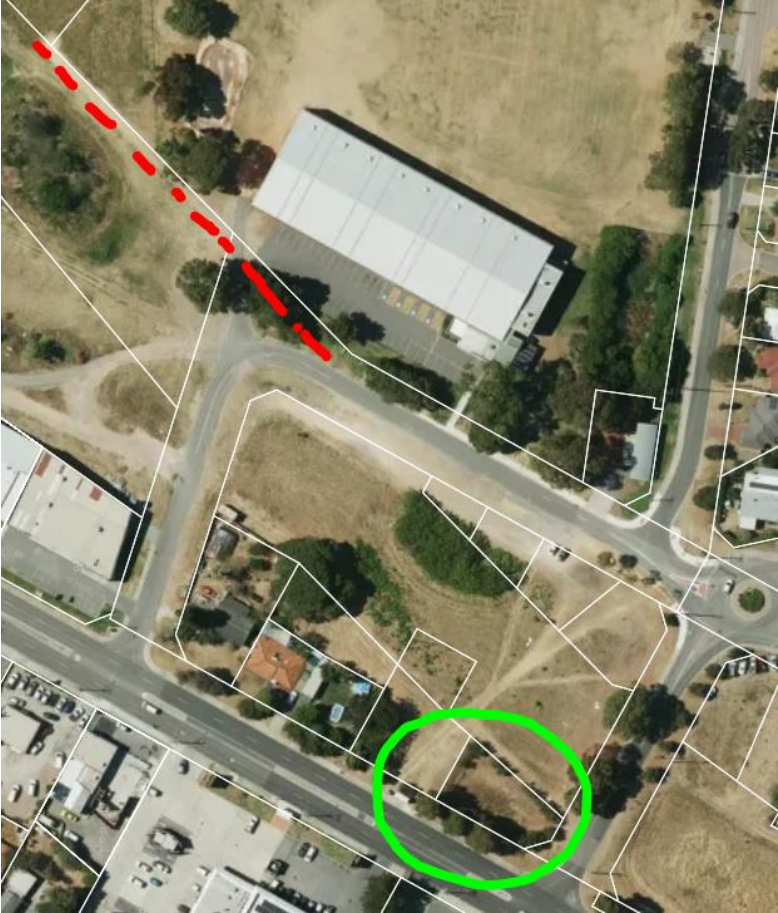
Gas	<p>There is existing natural gas infrastructure in Starling Street and Rockingham Road. There appears to be an existing supply to the existing Basketball Centre and House 62. At this stage, NDY does not have any information on the capacity of these supplies but can be confirmed with ATCO.</p> <p>Existing connections could be utilised where suitable or Subject to ATCO's approval, new gas supplies can be provided to suit the redevelopment needs. Keeping in line with the current sustainability practices in the industry, we do not envisage a need to increase the gas supply to the site.</p>	<p>There is existing natural gas infrastructure in Carrington Street and Rockingham Road as shown in Figures 8 and 9 below. There also appears to be an existing supply to few of the existing lots within the proposed site. At this stage, NDY does not have any information on the capacity of these supplies, but these can be confirmed with ATCO. Existing connections could be utilised where suitable or subject to ATCO's approval, new gas supplies can be provided to suit the requirements of the proposed development.</p>

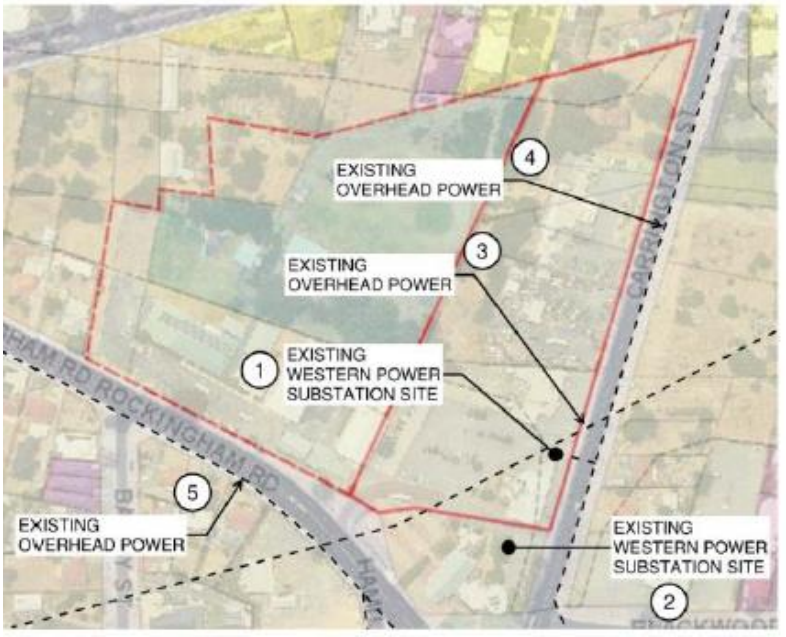
Electrical	<p>There are existing Western Power and Telstra infrastructure at Site. Summary of these services are in table below:</p>	<p>There are existing Western Power and Telstra infrastructure at Site 3</p>

Item	Site 1.5 – Current WHBS location plus Site 2		Site 3 – Carrington Street & Rockingham Road Precinct	
	<b>I.D.</b>	<b>DESCRIPTION</b>	<b>DESIGN CONSIDERATIONS</b>	
	1	Existing Western Power Substation 1	<p>The existing substation is understood to supply:</p> <ul style="list-style-type: none"> <li>Existing Wally Hagan Basketball Stadium.</li> <li>Existing The Hub 6163.</li> <li>Surrounding residential neighbouring properties.</li> <li>Surrounding street lighting.</li> </ul> <p>The capacity of this substation is currently unknown. Should capacity be insufficient, there is potential for the substation to be upgraded (pending Western Power confirmation).</p>	
	2	Existing Western Power Substation 2	<p>The existing substation is understood to supply:</p> <ul style="list-style-type: none"> <li>Residential neighbouring properties in Site 1.5 (north of Rockingham Rd).</li> <li>Existing Commercial precinct on Rockingham Rd.</li> <li>Surrounding residential neighbouring properties.</li> <li>Surrounding street lighting.</li> </ul> <p>This substation could be utilised for the Site 1.5 redevelopment (pending site arrangement) or could be isolated from Site 1.5 should multiple lots be amalgamated as part of the project and utilise Existing Western Power Substation 1.</p>

3	Existing Overhead Power	<p>The existing overhead powerlines consist of both low voltage distribution and high voltage transmission.</p> <ul style="list-style-type: none"> <li>Safe working around overhead lines should be considered in design and construction stages.</li> <li>Consideration for relocation of overhead lines (or sections of) to underground should be considered in overall design.</li> </ul>	
	4	Existing Overhead Power	<p>The existing overhead powerlines consist of both low voltage distribution and high voltage distribution.</p>	
	5	Existing Overhead Power	<p>The existing overhead powerlines consist of both low voltage distribution and high voltage distribution.</p> <ul style="list-style-type: none"> <li>Safe working around overhead lines should be considered in design and construction stages.</li> <li>Consideration for relocation of overhead lines (or sections of) to underground should be considered in overall design.</li> </ul>

6	Existing Telstra	<p>There is existing Telstra infrastructure within the proposed Site 1.5 development. Relocation/modification of these existing services could be required pending final site arrangement.</p>	
	1	Existing Western Power Substation 1	<p>The existing substation is understood to supply:</p> <ul style="list-style-type: none"> <li>Existing multiple Lots making up Site 3.</li> <li>Surrounding commercial neighbouring properties.</li> <li>Surrounding residential neighbouring properties.</li> <li>Surrounding street lighting.</li> </ul> <p>The capacity of this substation is currently unknown. Should capacity be</p>	
	I.D.	DESCRIPTION	DESIGN CONSIDERATIONS

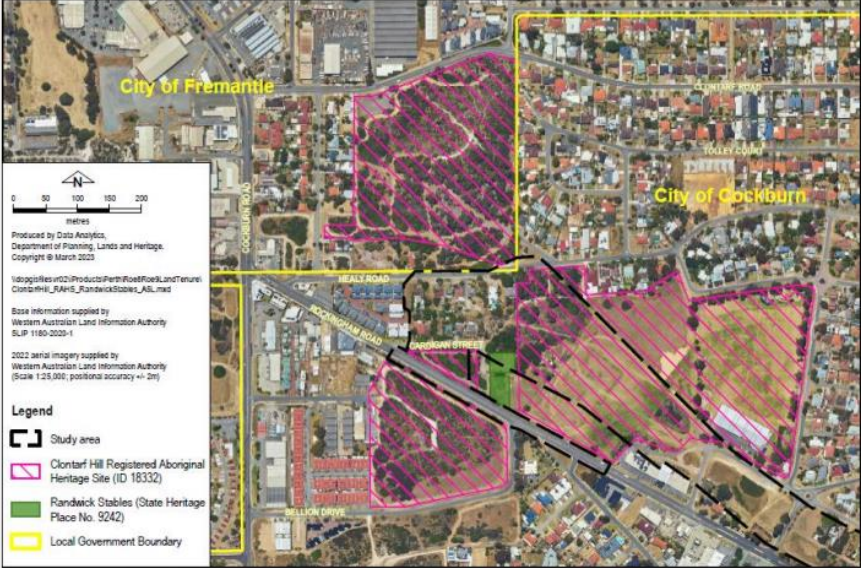
A registered Aboriginal Heritage Place (Clontarf Hill) encompasses various land parcels within and beyond the PRR reservation. This Aboriginal heritage place is understood to include a massacre site.

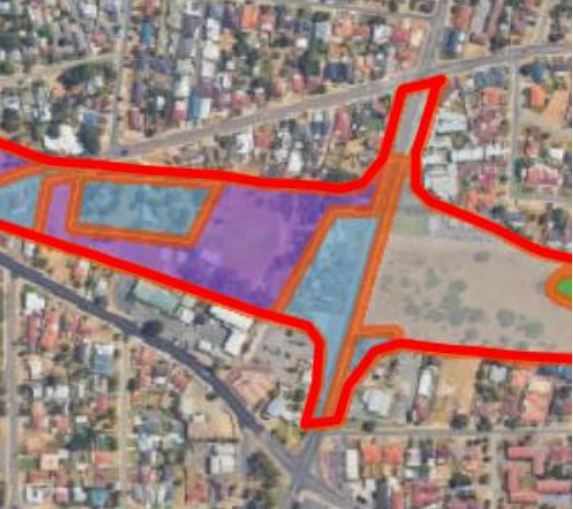
<p data-bbox="414 670 1041 694">Existing Wally Hagan site and Dixon Park in Parkland zone.</p> <p data-bbox="324 710 403 726"><b>LEGEND</b></p> <table border="0" data-bbox="324 734 1187 1037"> <tr> <td>● <i>Dodonaea hackettiana</i></td> <td>Study area</td> <td><b>Vegetation Units</b></td> </tr> <tr> <td>Banksia Woodlands of the Swan Coastal Plain (Threatened) ecological community</td> <td>Very Good</td> <td>(Eg)EmCcBam</td> </tr> <tr> <td>Tuart (<i>Eucalyptus gomphocephala</i>) Woodlands and Forests of the Swan Coastal Plain (Threatened) ecological community</td> <td>Degraded - Good</td> <td>ArBss</td> </tr> <tr> <td>Coastal shrublands on shallow sands, southern Swan Coastal Plain (FCT 29a; Priority 3)</td> <td>Degraded</td> <td>C (Cleared)</td> </tr> <tr> <td></td> <td>Degraded - Completely Degraded</td> <td>EgBaXp</td> </tr> <tr> <td></td> <td>Completely Degraded</td> <td>EgD</td> </tr> <tr> <td></td> <td></td> <td>INF</td> </tr> <tr> <td></td> <td></td> <td>JfKq (Rehab)</td> </tr> <tr> <td></td> <td></td> <td>P (Plantings)</td> </tr> <tr> <td></td> <td></td> <td>PC (Parkland Cleared)</td> </tr> <tr> <td></td> <td></td> <td>Pk (Parkland)</td> </tr> </table>	● <i>Dodonaea hackettiana</i>	Study area	<b>Vegetation Units</b>	Banksia Woodlands of the Swan Coastal Plain (Threatened) ecological community	Very Good	(Eg)EmCcBam	Tuart ( <i>Eucalyptus gomphocephala</i> ) Woodlands and Forests of the Swan Coastal Plain (Threatened) ecological community	Degraded - Good	ArBss	Coastal shrublands on shallow sands, southern Swan Coastal Plain (FCT 29a; Priority 3)	Degraded	C (Cleared)		Degraded - Completely Degraded	EgBaXp		Completely Degraded	EgD			INF			JfKq (Rehab)			P (Plantings)			PC (Parkland Cleared)			Pk (Parkland)

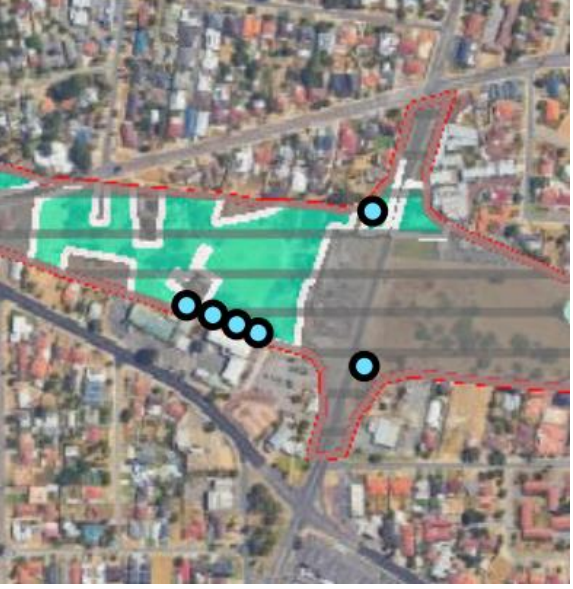
<p data-bbox="1220 750 1624 774">Parkland cleared – Indicated in green.</p> <p data-bbox="1220 790 1332 805"><b>LEGEND</b></p> <table border="0" data-bbox="1220 813 2094 1252"> <tr> <td>Study area</td> <td><b>Foraging habitat quality</b></td> </tr> <tr> <td><b>Potential habitat trees</b></td> <td>High</td> </tr> <tr> <td>● No hollows</td> <td>Low</td> </tr> <tr> <td>○ Suitable hollow/s but no evidence of Black Cockatoo use</td> <td>None (Cleared)</td> </tr> <tr> <td>○ Unsuitable hollow/s</td> <td><b>Habitat types</b></td> </tr> <tr> <td><b>Species records</b></td> <td>Banksia and eucalypt woodland</td> </tr> <tr> <td>★ Carnaby's Cockatoo (EN) sighted flying over</td> <td>Parkland cleared</td> </tr> <tr> <td>+ Forest Red-tailed Black Cockatoo (VU) foraging evidence</td> <td>Tuart woodland</td> </tr> <tr> <td>▲ Quenda (P4) diggings</td> <td>Shrubland</td> </tr> <tr> <td>■ Quenda (P4) sighting</td> <td>Cleared</td> </tr> </table> <p data-bbox="2027 1197 2060 1220">a</p> <p data-bbox="1814 1252 2094 1268"><b>Ecological values</b></p> <table border="0" data-bbox="1814 1292 2016 1436"> <tr> <td>Low</td> </tr> <tr> <td>Medium</td> </tr> <tr> <td>High</td> </tr> </table>
