LOCAL WATER MANAGEMENT STRATEGY

Cockburn Central West

Report No: D12211 Version/Date: Rev 2, June 2014

LANDCORP

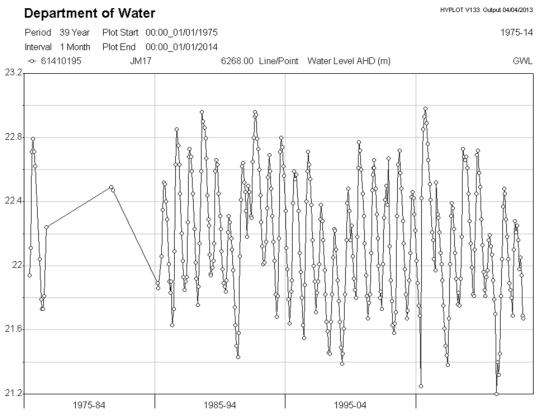
Graph I: Hydrograph for WIN Bore JM 17

The hydrograph from DoW bore JM-17 is shown in Graph I below. The hydrograph suggests that annual peak groundwater elevations in the monitoring period were within \pm 50 cm of the AAMGL for the last 10 years in this bore.

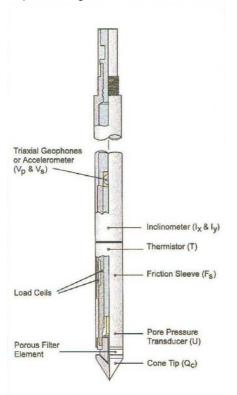
Figure 1: Cone Diagram

- Cone tip resistance
- Sleeve friction
- Inclination (from vertical)
- Depth below ground

The inclinometer in the cone enables the verticality of the test to be confirmed and, if required, the vertical depth can be corrected.

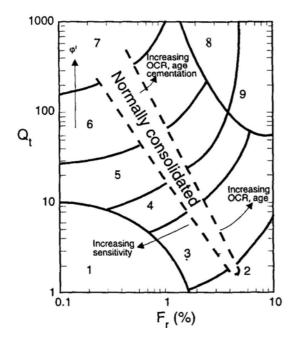
Figure 3: Soil Classification Chart

The CPT parameters can be used to infer the Soil Behaviour Type (SBT), based on normalised values of cone resistance (Qt) and friction ratio (Fr). These are used in conjunction with soil classification charts, such as the one below (after Robertson 1990)

DP's in-house CPT software provides computer aided interpretation of soil strata, generating soil descriptions and strengths for each layer. The software can also produce plots of estimated soil parameters, including modulus, friction angle, relative density, shear strength and over consolidation ratio.

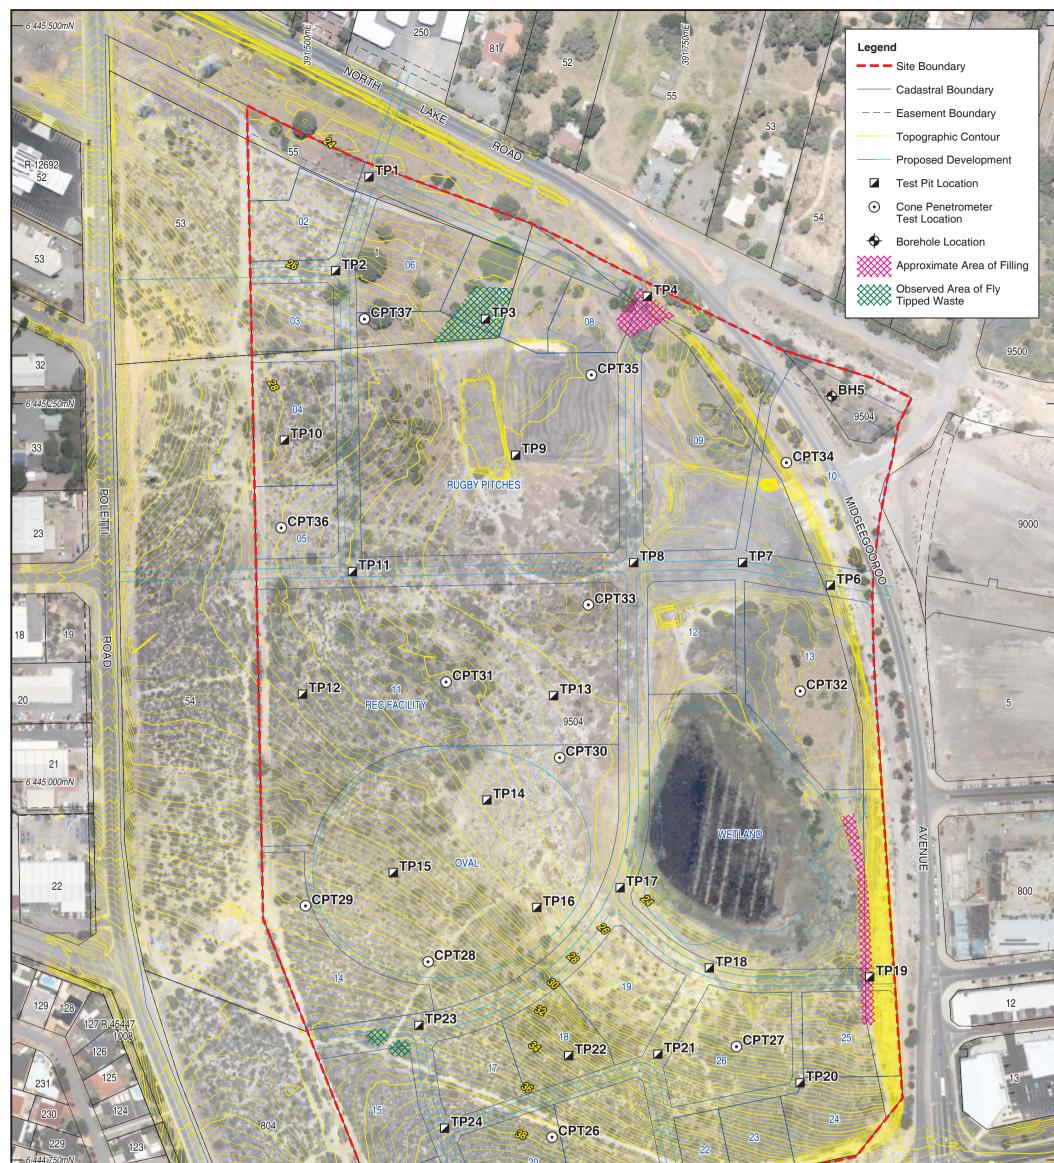
Prior to excavation for foundations and/or placement of filling, all deleterious material, including vegetation, topsoil and fly tipped materials should be stripped from the proposed building and car park footprints, and removed from site. Topsoil could be re-used for landscaping purposes. It should be noted that the filling at TP19 was found to have an organic content of 5.9% and is considered unsuitable for use as structural filling at the site. This layer should be excavated and either screened, blended with another material with a lower organic content, used for landscaping purposes or removed from site. The estimated extent of the filling layer at TP19 is defined in Drawing 1.

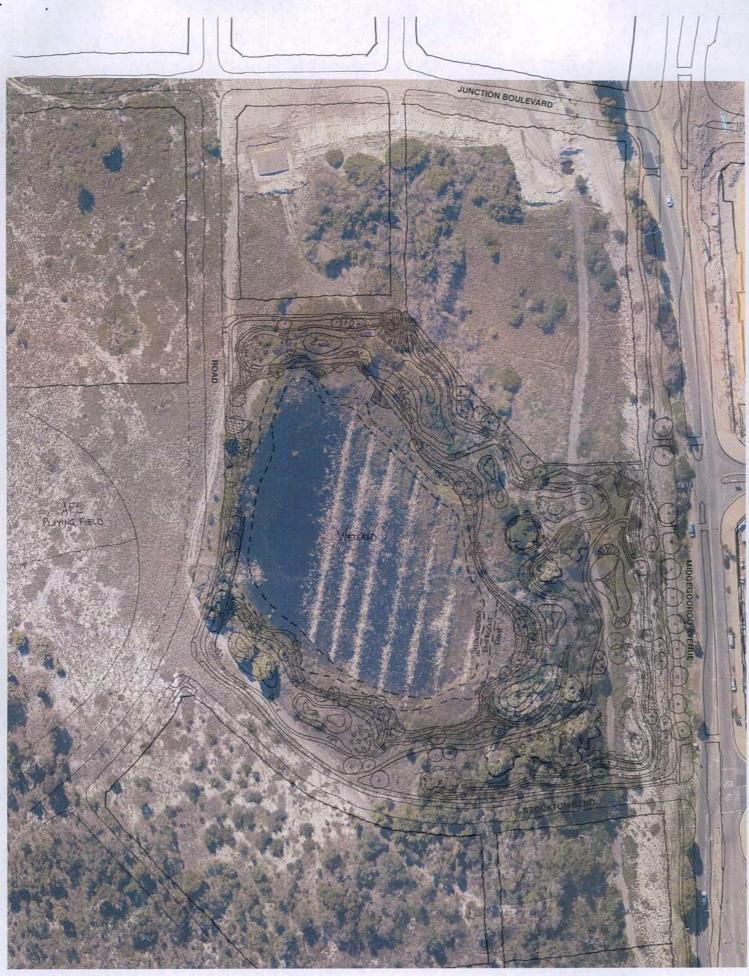
Perdit Tent 15:05 Centrage Tenture DRAFT Wetland Concep

DRAFT CONCEPT ONLY Subject to further design, study, engineering Input, survey and council approval.

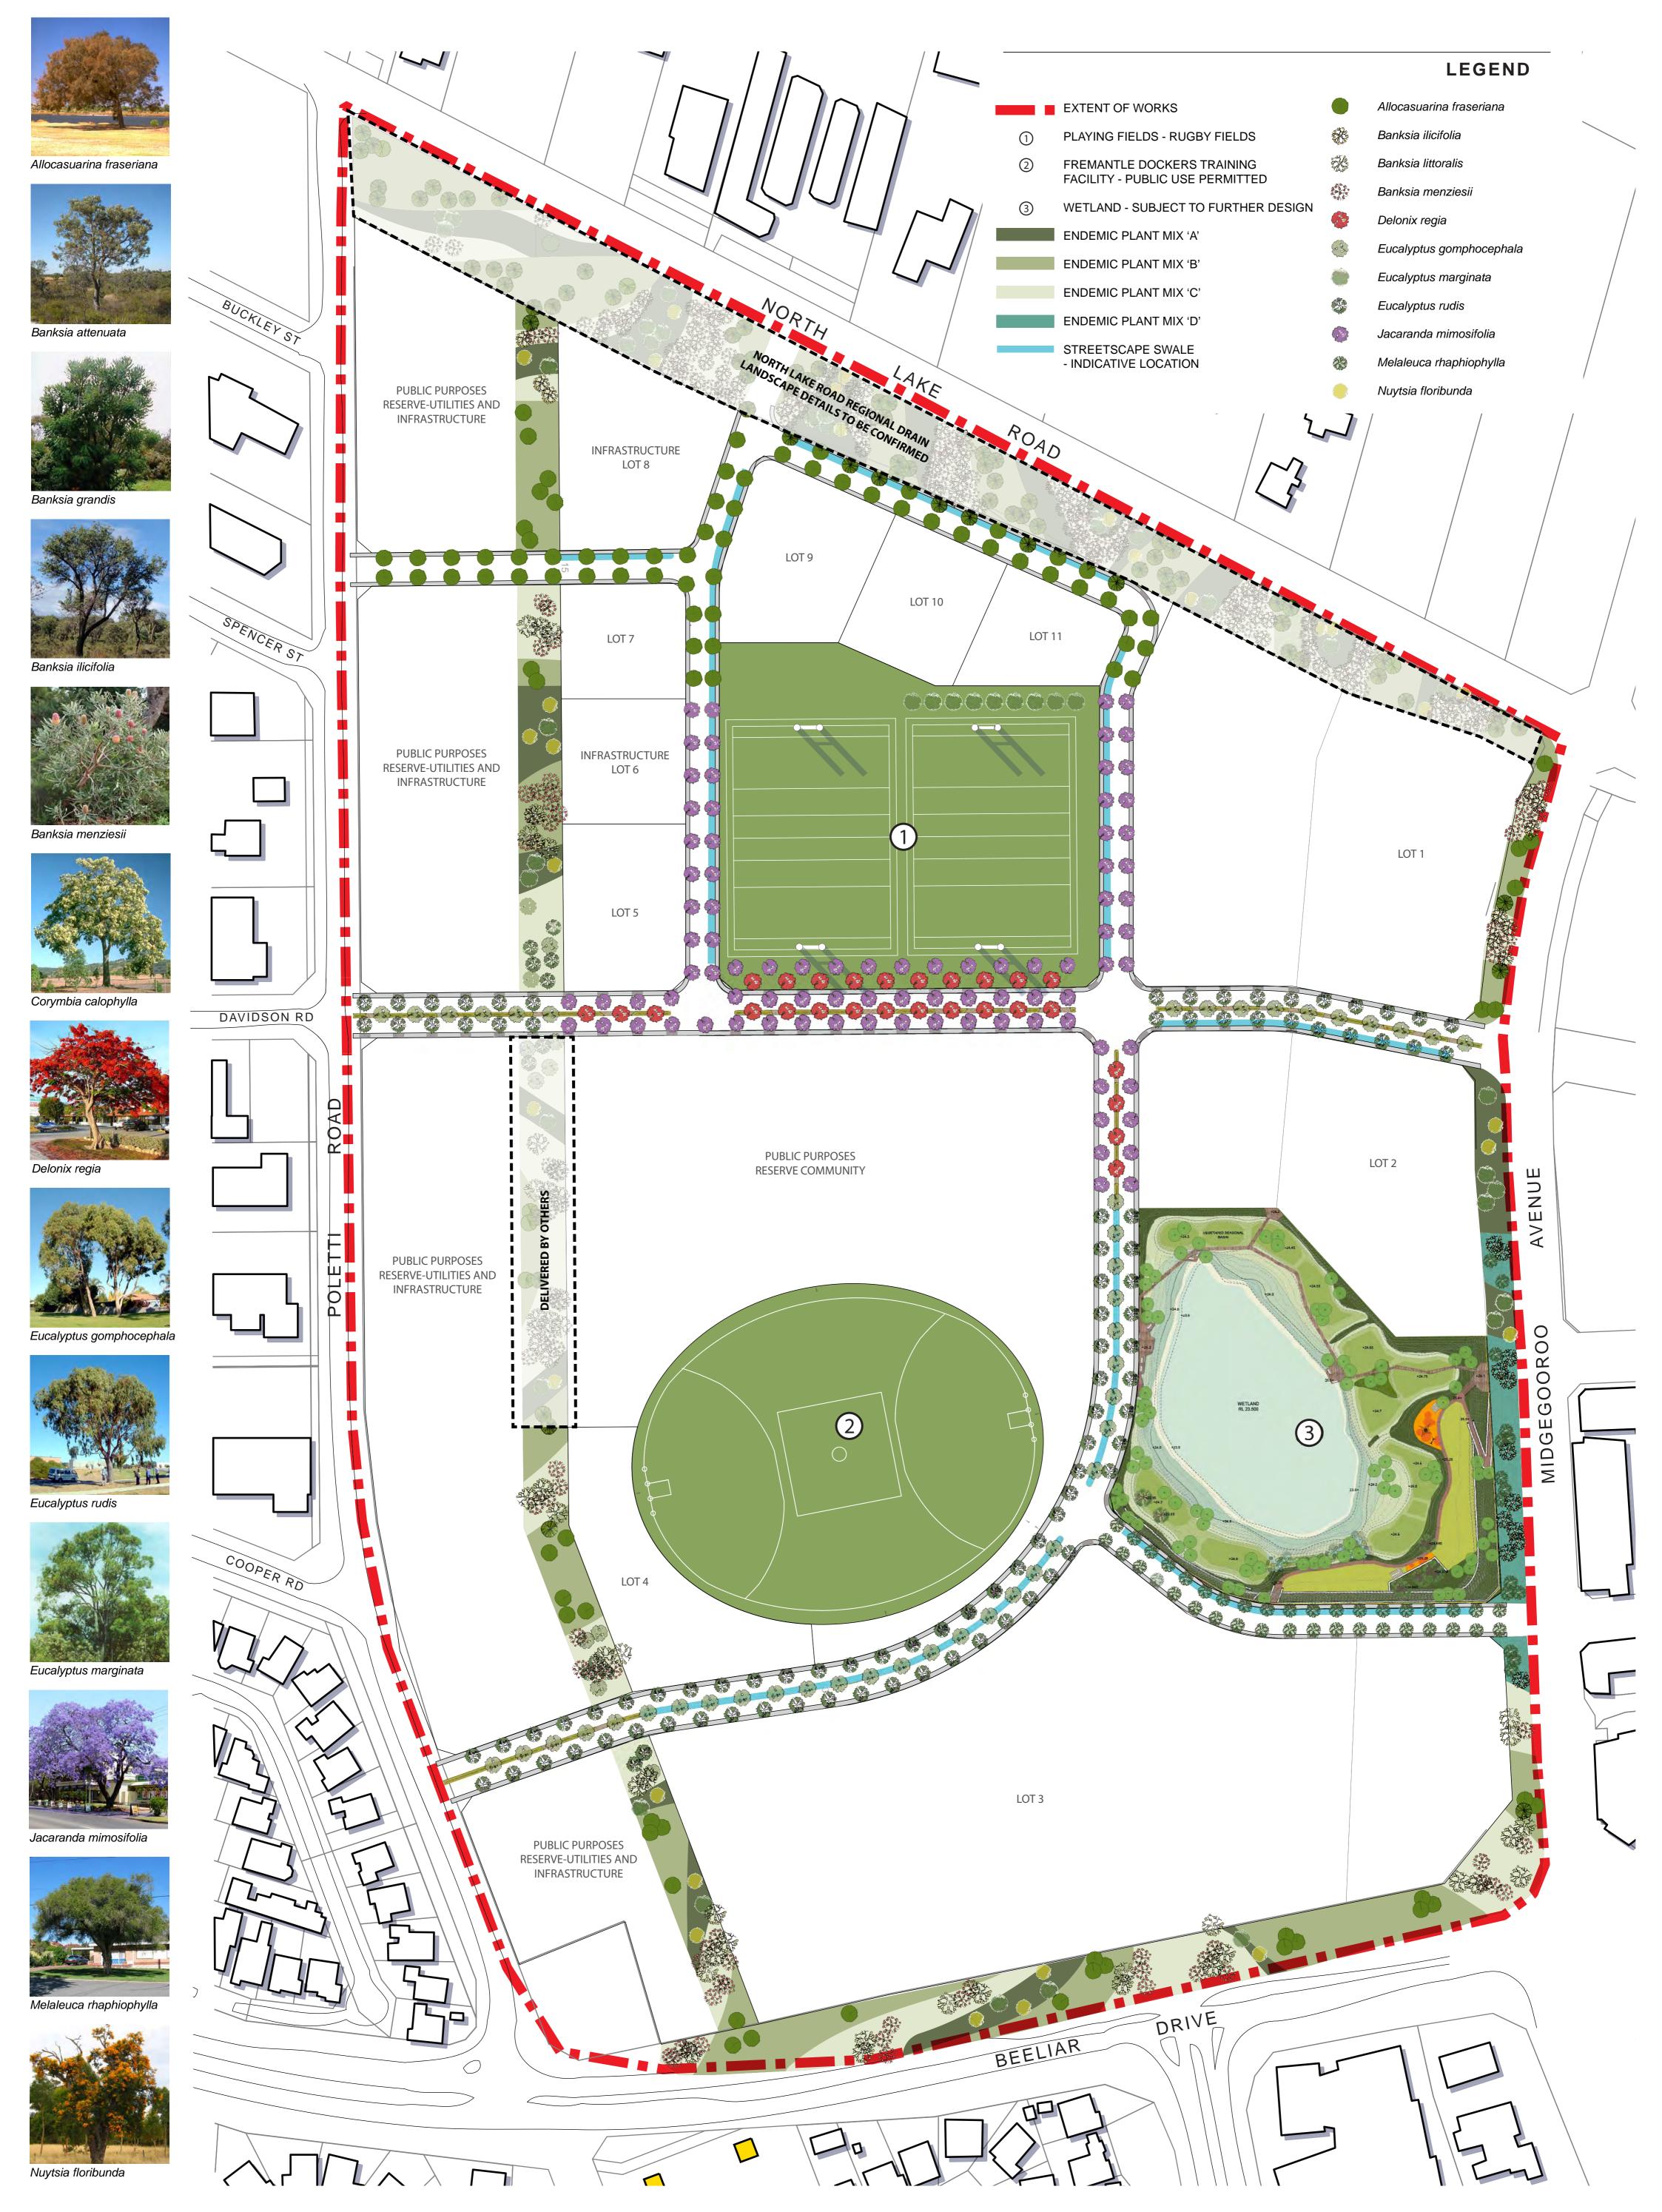
AUTHOR: TC QA: IU PROJECT NO: 3160-14 SCALE 1:1250 @ A1 0 100 200m bh: (08) 9430 8955 web: www.ecoscape.com.au	STREET TREE MASTER PLAN
--	-------------------------

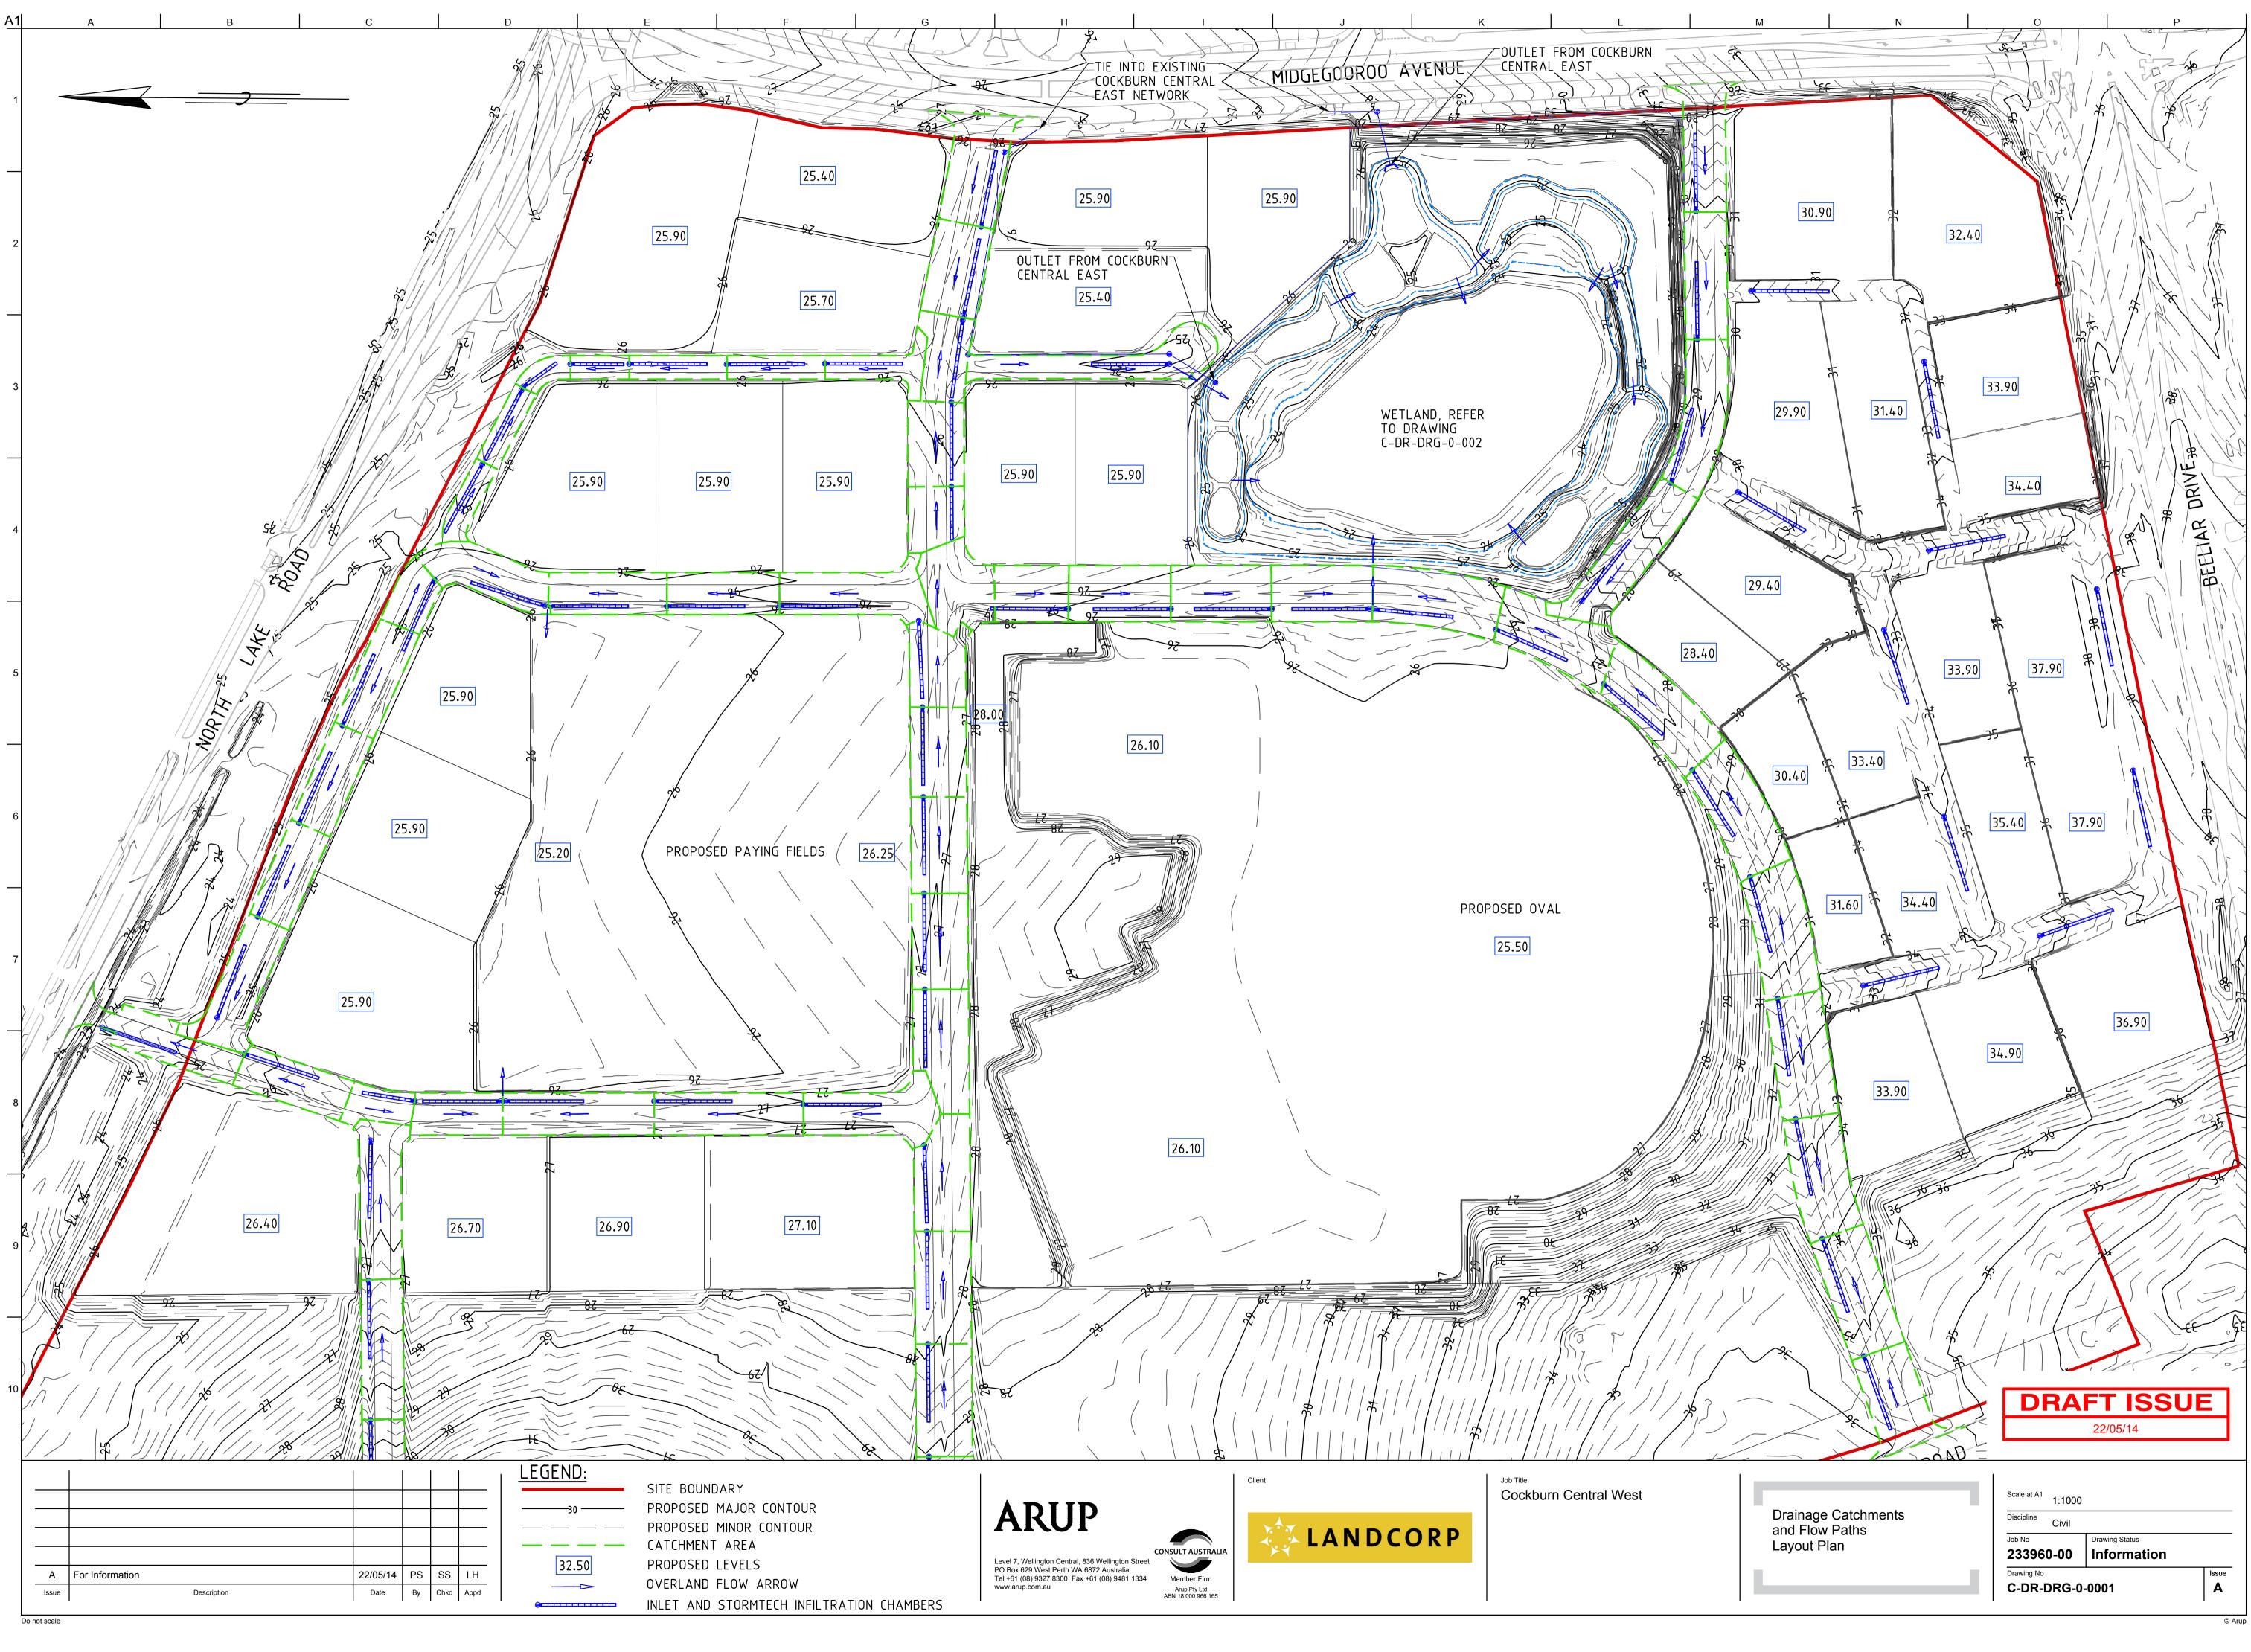
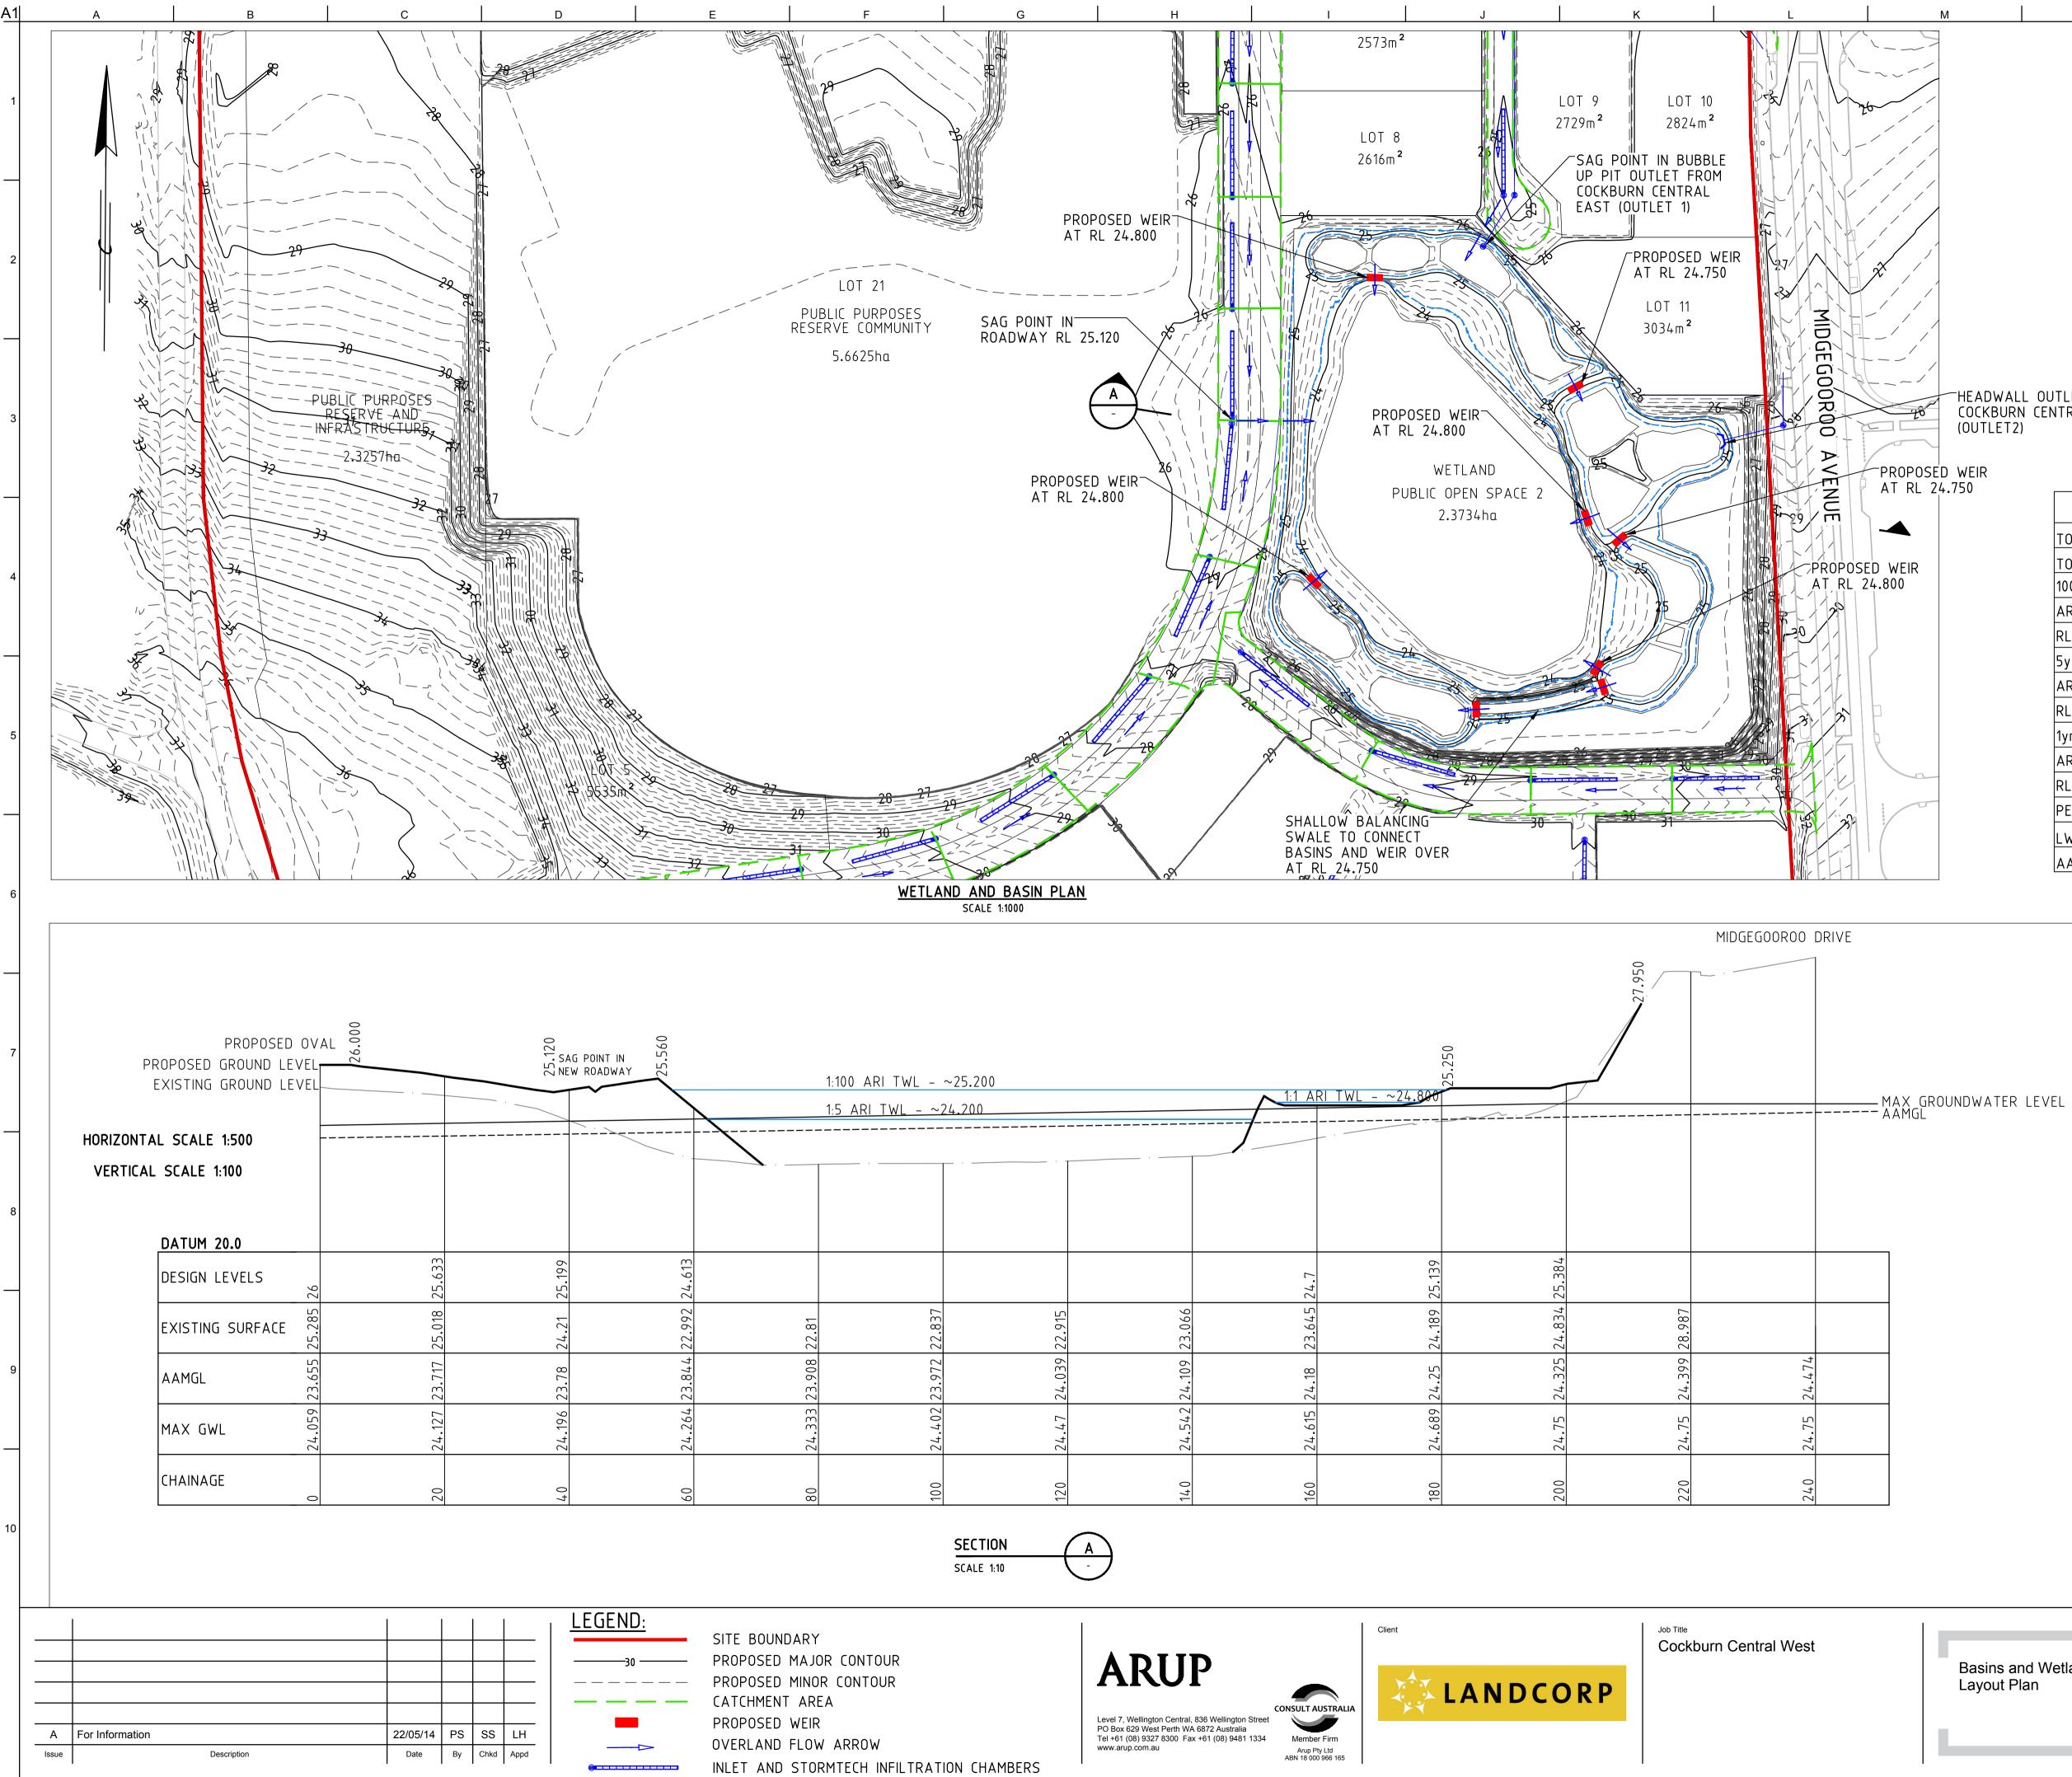
Basins and Wetland Treatment Layout Plan

The intent of the wetland bio-filtration swales will be to retain and treat the first flush (I year I hr ARI storms). In order to infiltrate successfully, these basins need to be above the MGL and the AAMGL, hence the introduction of the bubble up pit. The storage required for the first flush storm has been calculated as approximately 1,050 m³. This volume has been allowed for in the basins around the wetland, which have been proposed to be interconnected with weirs and swales. The larger design storms, such as the 5-year ARI will also pass through the same outfall and basin system, but will overtop the swales and enter the wetland.

HEADWALL OUTLET FROM COCKBURN CENTRAL EAST (OUTLET2)
